Installation Instructions:

Opel Frontera

1989 - 1998

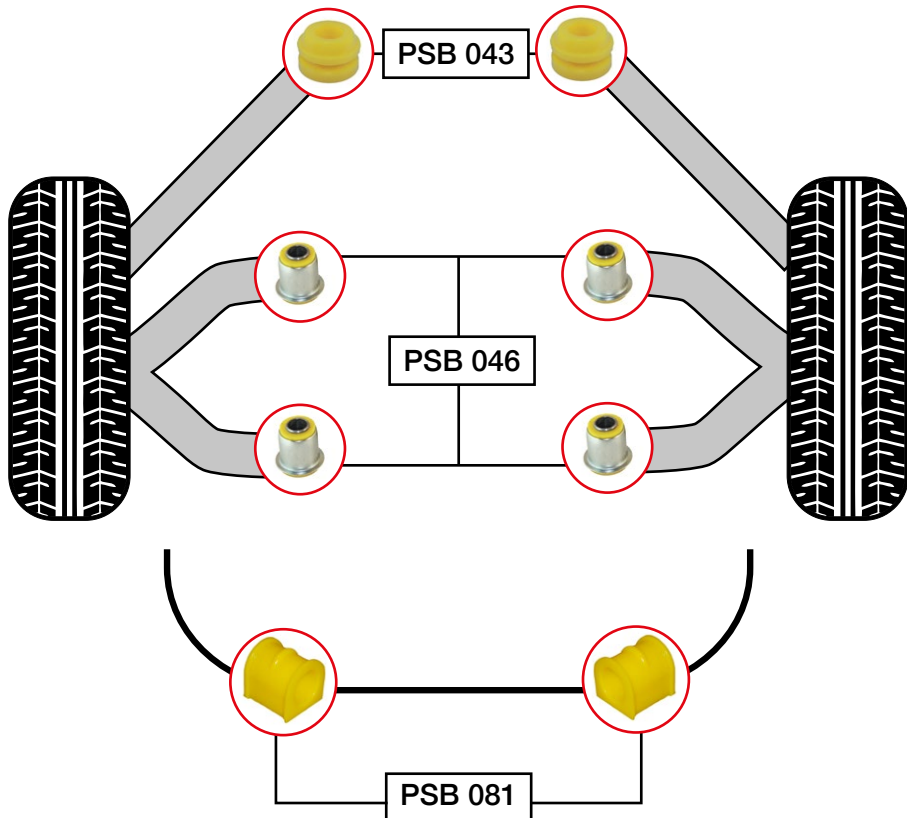
FRONT

Front Tension rod Bushing
OE Number: 8944336720

Front Upper arm Bushing
OE Number: 8944088403

Anti Roll / Sway Bar Bushing
OE Number: 8-97247-083-0

1. Remove metal bracket of original rubber bushing.
2. Ensure outer metal casing of original rubber bushing is removed, which can be done by cutting with a hacksaw and knocking out with a chisel.
3. Clean housing with sand paper to remove sharp edges.
4. Use mechanical press to install new bushing, making sure that it is in the same position as the original bushing that has just been removed.
5. The installation is complete.

1. Remove metal bracket of original rubber bushing.
2. Remove old rubber bushing and clean bar.
3. Find slit on new poly bushing and slide over the bar.
4. Refit metal bracket.
5. The installation is complete.

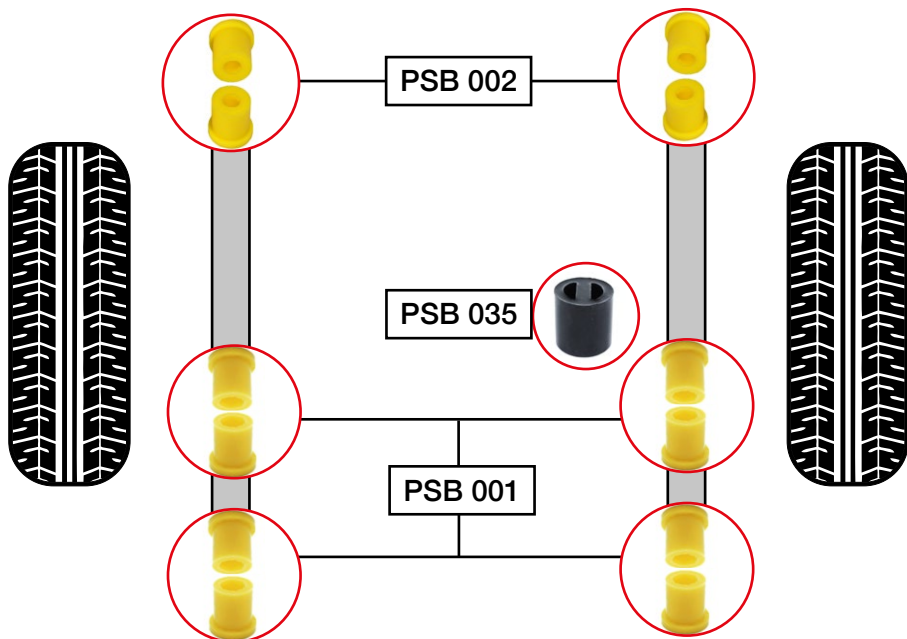
REAR

(Installation instructions same as PSB 001)
Rear Spring Front Bushing
OE Number : 55045-01W10

Exhaust Hanger Bushing

Rear Spring Rear Upper/Lower Shackle Bushing
OE number : 8942343190

1. Take the weight of the vehicle off the leaf spring.
2. Unbolt the shackle hangar.
3. Remove the old bushing off the bolt.
4. Replace with new poly bushings.
5. Bolt up the spring shackle to the chassis.
6. The installation is complete.
